Capping of the Excavation Cut for a New High-Speed Railroad Line in Spain

Construction of new railroad line Córdoba to Málaga, Spain

Railroad section Puente Genil – Herrera, Spain

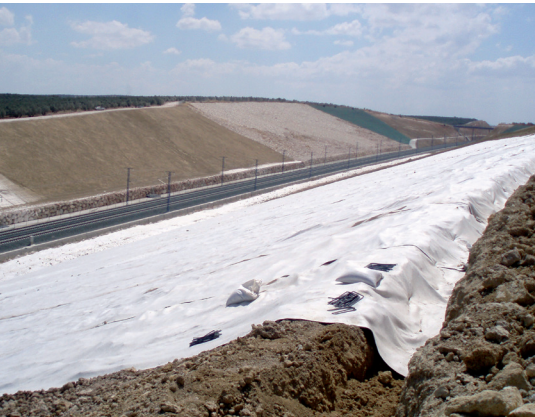
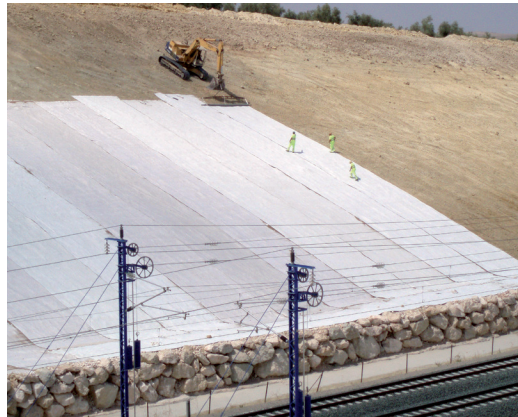
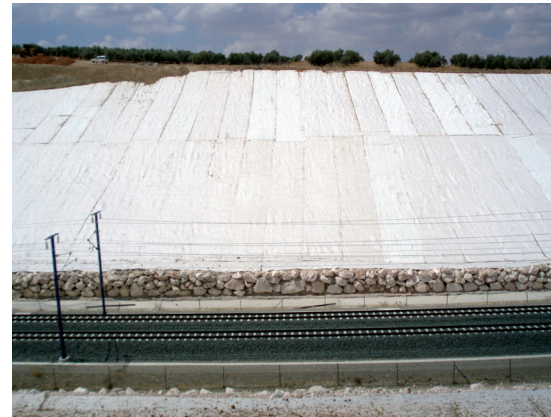
CETCO engineers recommended to cutoff sensitive soils from potential rainfall by using a BENTOMAT® AS geosynthetic clay liner (GCL). For steeper slopes a cellular confinement system (CETCOCELL) was also recommended to be installed on top of the BENTOMAT® AS GCL to prevent surface runoff or severe erosion problems. This proposed solution was benchmarked against other lining systems but the CETCO GCL solution proved to be the most efficient and reliable liner for this application. BENTOMAT® AS GCL and CETCOCELL turned out to be the most durable, competitive and cost-efficient solution.

Since construction was already delayed, the installation of BENTOMAT® AS GCL was carried out quickly to allow for consecutive works to be progressed without further delays. BENTOMAT® AS GCL proved to be extremely efficient and feasible for this kind of emergency work.
