# ORGANOCLAY Permeable Reactive Barrier Utilized to Control NAPL Contamination

Bay Project – Union Pacific Railroad  
Engineer: Ch2M Hill  
Contractor: Ch2M Hill Construction  
Subcontractor: DeWind Dewatering

Escanaba, MI

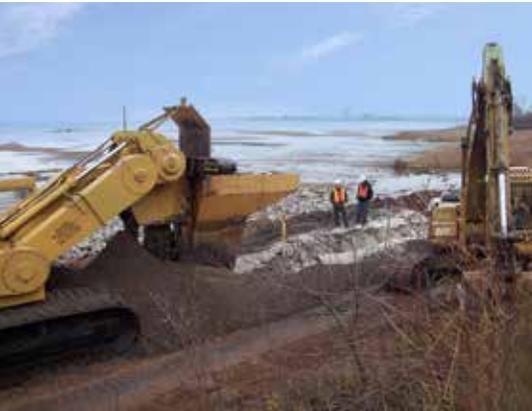
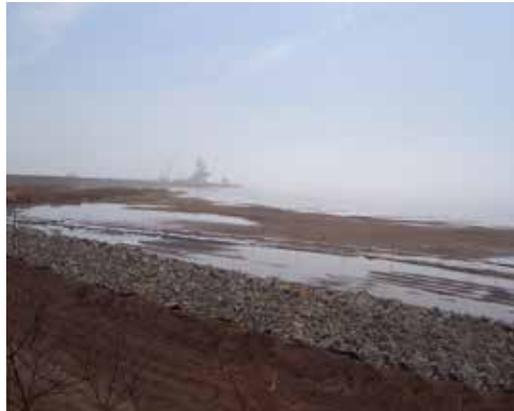
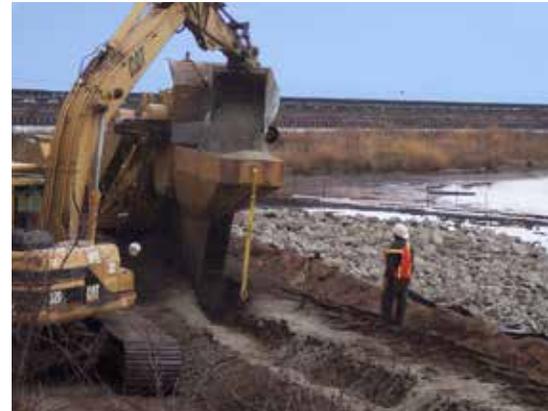
Approximately 15 ft (5 m) up gradient of the RCM a permeable reactive barrier wall was installed. One part organoclay was mixed with 3 parts of ¼ inch (6 mm) pea gravel by volume in a stockpile. A continuous trenching machine placed the organoclay-gravel mix in an 18 inch (45 cm) wide by 10 ft (3 m) deep by 240 ft (80 m) long trench. The organoclay PRB was completed in one day.

To stop the pollution from spreading through the bay and into Lake Michigan, an interim measure was taken which consisted of installing a permeable reactive barrier (PRB) containing ORGANOCLAY® media and CETCO REACTIVE CORE MAT® (RCM) along the affected stretch of beach and a permeable reactive wall behind the RCM.
