Active sediment cap included in clean-up strategy at high-profile superfund site

BROS Superfund Site

Logan Township, New Jersey, U.S.A

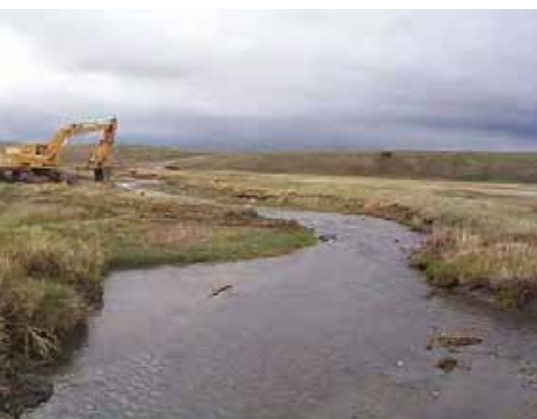
Images (Left to Right) – Site work prior to the installation of REACTIVE CORE MAT® (Left). REACTIVE CORE MAT® being spread out on the site (middle). Additional site and water remediation that was performed on the site as part of the overall remediation strategy (right).
