# Activated carbon mat utilized in subaqueous cap on major superfund site

Stryker Bay

## LOCATION

Duluth, Minnesota, USA

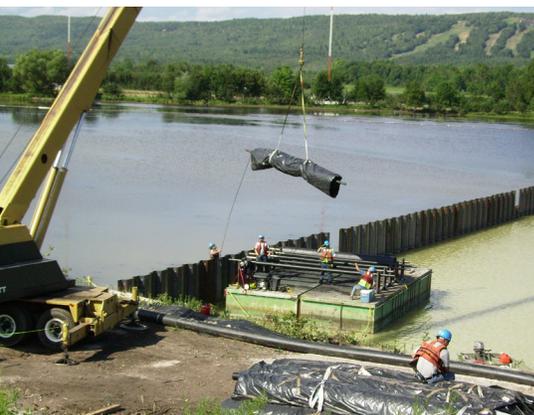
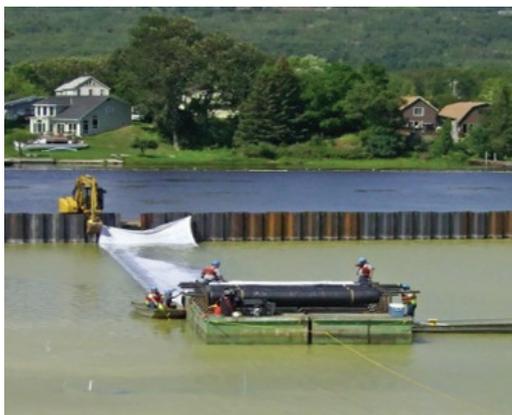
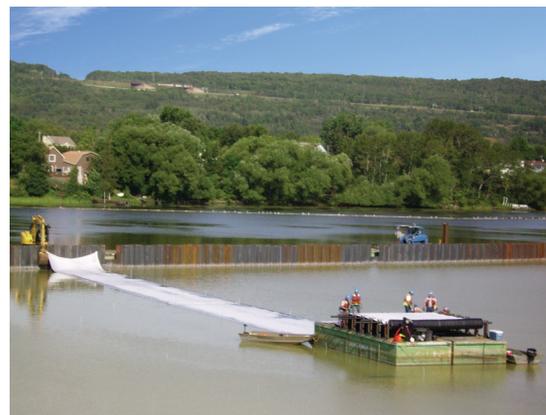
In total, 500,000 square feet of REACTIVE CORE MAT® (RCM) filled with Granular Activated Carbon (GAC) was installed by a CETCO trained and certified installer. The RCM was installed on a reel fastened to the deck of a barge and unreeled over the advancing side of the barge using an idler roller. The starting end of the RCM was anchored at the shore and a guide float system was used to keep the RCM placement in the intended location. RCM was also deployed along the shoreline and covered with a sand layer.
