Strict quality assurance procedures ensure reliable vapor intrusion protection

Toronto Fire Services

LIQUID BOOT® Spray-Applied Vapor Barrier

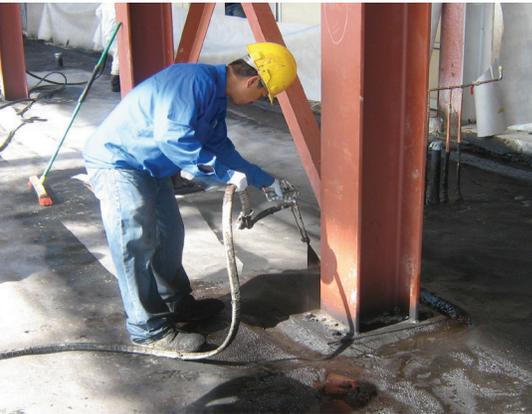
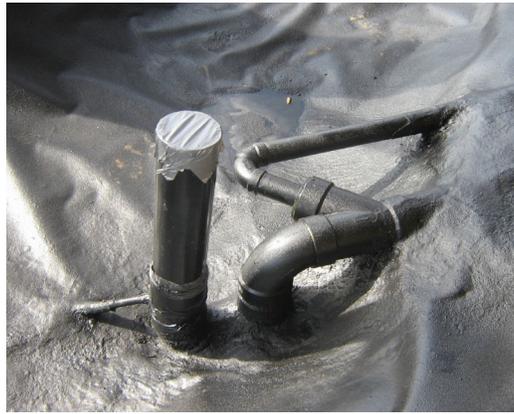
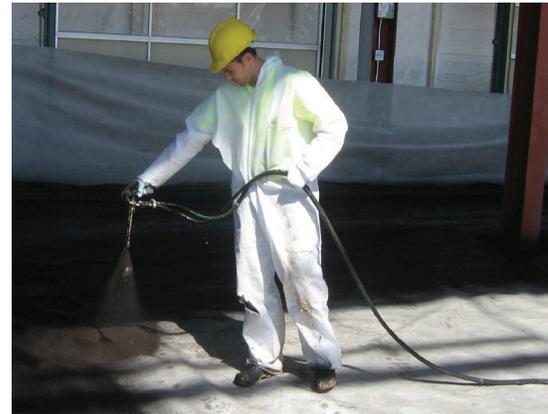
Approved LIQUID BOOT® installer, Terrafix Environmental, ensures a proper installation and a vapor-tight seal around all penetration and footings, critical vapor intrusion pathway areas that present the most potential risk for compromised indoor air quality within the structure. LIQUID BOOT® can only be installed by those trained and approved by CETCO, helping to ensure a quality and reliable gas vapor membrane system for your project.

The engineer, with the assistance from approved LIQUID BOOT® vapor barrier installer was able to develop a comprehensive gas vapor mitigation strategy for the site to prevent vapor intrusion into the structure. As part of the remedial strategy, Terrafix Environmental performed two smoke tests on the site, one of which took place after the initial installation of the LIQUID BOOT® vapor barrier. A second smoke test was conducted after installation of the rebar, which had been done so by another sub-contractor, which consequently revealed damage to the membrane had been caused by the rebar contractor.

Unlike HDPE, gas vapor barriers that prove more difficult and labor-intensive to repair, the spray-application benefit of LIQUID BOOT® vapor barrier allows it to be easily repaired by simply re-spraying the compromised area or pinhole.

CETCO approved installers efficiently installed the LIQUID BOOT® vapor barrier on schedule and execution of two smoke tests helped to ensure the integrity of the vapor tight membrane, thus preventing vapor intrusion from entering the building.
