Remedial strategy at superfund site calls for ORGANOCLAY[™] sediment cap

PROJECT DETAILS

Port of Portland Nearshore Cap Design Engineer: Anchor QEA General Contractor: Hickey Marine

Portland, Oregon, USA

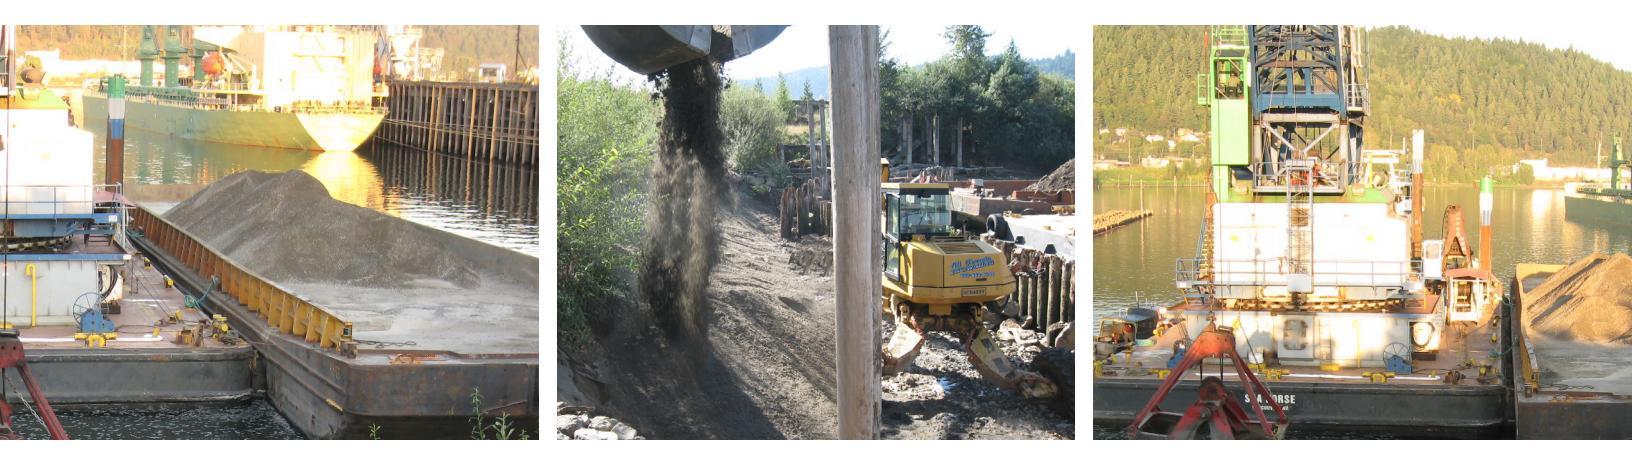
Bulk ORGANOCLAY easily accessible by barge (left). ORGANOCLAY being placed along the waterway embankment (middle). The subaqueous strategic application of the organophilic clay sediment cap (right).

The remediation strategy included dredging and off-site disposal of sediments exhibiting the highest chemical concentrations. Where dredging was not feasible, a organophilic clay nearshore cap, utilizing 850 tons of CETCO's bulk ORGANOCLAY, was constructed to isolate petroleum contaminated sediments from aquatic receptors and control a potential ongoing source to nearby areas. In addition, stabilization of the Wheeler Bay bank was also part of the remedial strategy in order to minimize contaminant migration to the river. Lastly, dredging and off-site disposal of the contaminated sediments in Slip 3 at Berth 410 commenced in support of overall risk reduction in the Removal Action Area.
