CETCO vapor mitigation system chosen as protection for high-profile sports stadium

New York Red Bull Arena Engineer: Louis Berger Group General Contractor: Roberts Construction Group Certified Installer: EAI, Inc.

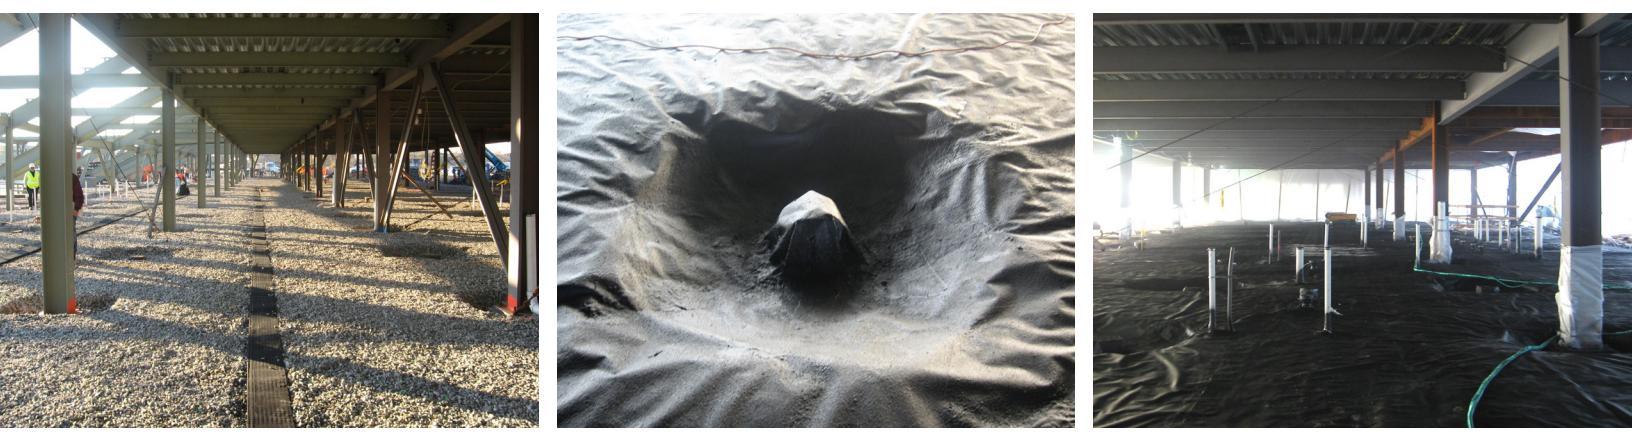
Left to right: installation of the GEOVENTTM sub slab venting system; spray-application allows for quick and air-tight seal around all penetrations and irregularities to save considerable time; installed spray-applied vapor membrane attaches to the piles themselves and conforms to the haunch.

As an approved LIQUID BOOT[®] vapor barrier applicator, EAI, Inc. installed the GEOVENT[™] sub slab venting directly into the stone sub-grade, connecting it to vent risers, which were run up the outside of the stadium. EAI, Inc. also installed 80,000 square feet of LIQUID BOOT[®] vapor barrier to the underslab of the stadium bleachers, sealing directly onto the timber piles and around haunched areas of the foundation. After installation, EAI performed rigorous QA/QC procedures, including a smoke test which pumped smoke underneath the entire membrane, in order to observe for any pinhole leaks. Once any needed repairs were made to the membrane, ensuring a vapor tight seal, the membrane was then protected with ULTRASHIELD[™] G-1000 protection course.
