GCL serves as cap in Brownfield remediation site

New Jersey Brownfield Remediation

Patterson, New Jersey, USA

BENTOMAT® SDN GCL

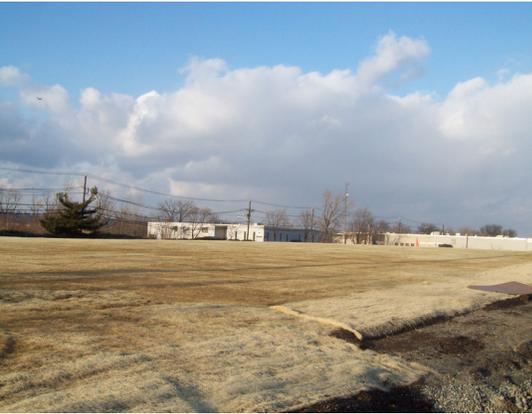
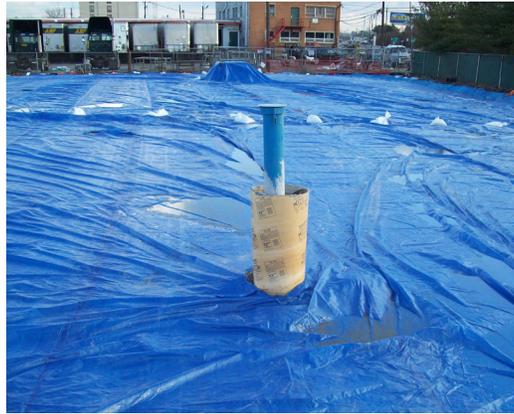
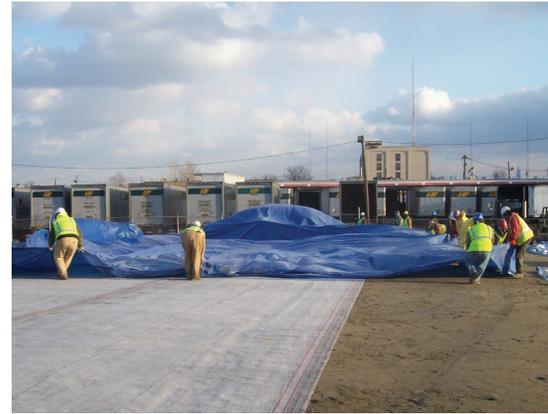
This New Jersey Brownfield was formerly the site of a chemical recycling facility.

The site was surrounded with a soil-bentonite slurry wall and topped with a six-acre geosynthetic cap. The geosynthetics were terminated at a corrugated sheet pile wall. Cast-in-place concrete with an embedded polyethylene strip was added to which the LLDPE geomembrane was welded. The BENTOMAT SDN GCL held up well in the high winds.
