Activated carbon mat utilized in subaqueous cap on major superfund site

Stryker Bay

Duluth, Minnesota, U.S.A

GAC REACTIVE CORE MAT®
with Granular Activated Carbon

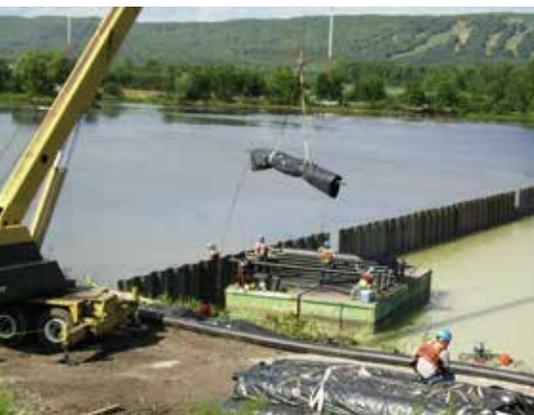
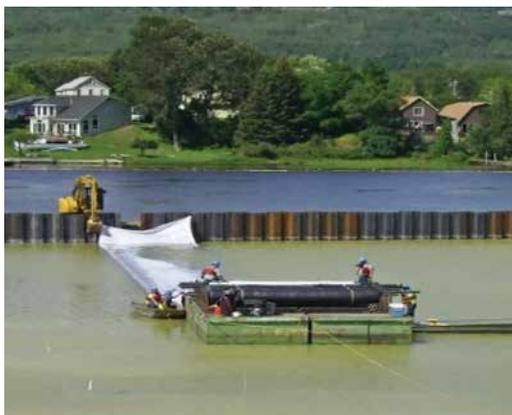
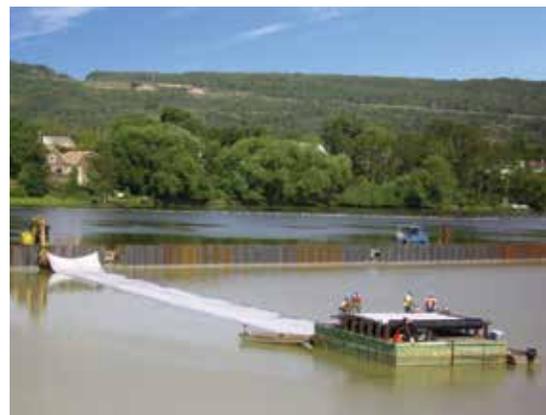
In total, 500,000 square feet of GAC REACTIVE CORE MAT® (RCM) was installed by a CETCO trained and certified installer. The RCM was installed on a reel fastened to the deck of a barge and unreel over the advancing side of the barge using an idler roller. The starting end of the RCM was anchored at the shore and a guide float system was used to keep the RCM placement in the intended location. RCM was also deployed along the shoreline and covered with a sand layer.
